METHOD AND APPARATUS FOR REMOTE FEATURE MEASUREMENT IN DISTORTED IMAGES

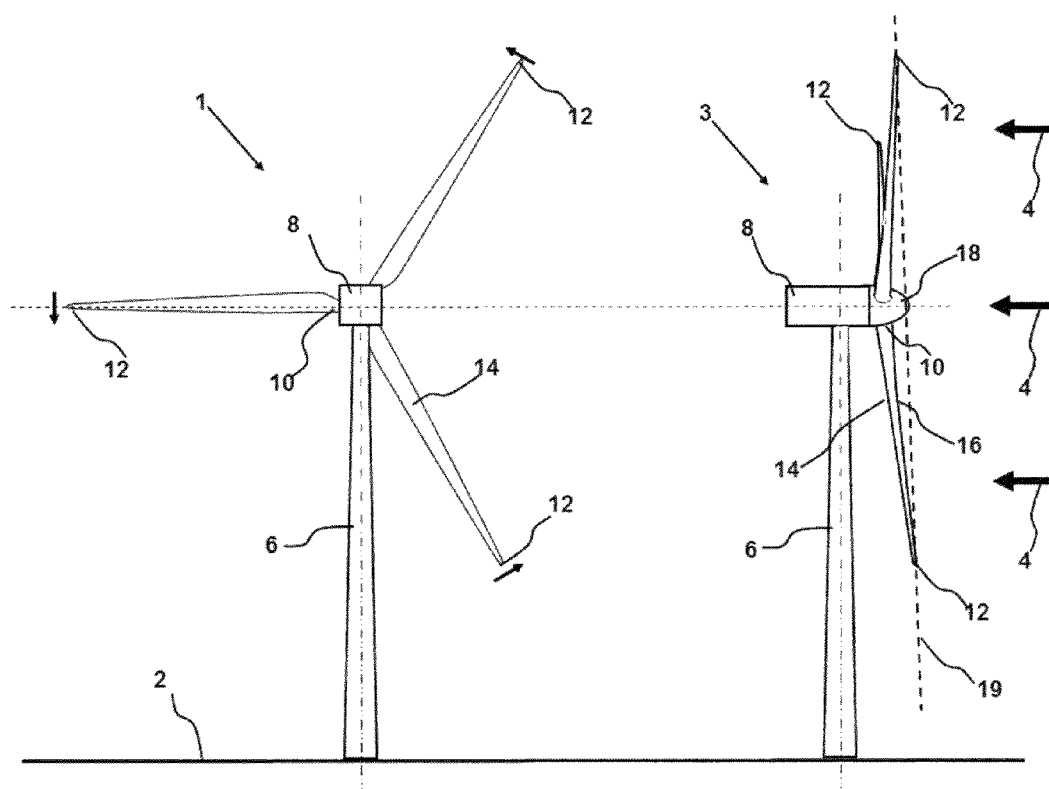
Fig. 1

FIG. 1 is a schematic representation of a utility scale, horizontal axis, wind turbine generator.

Referring now to the drawings, wherein like reference numerals indicate corresponding structure throughout, and referring in particular to FIG. 1, a schematic diagram of a HAWT is shown that is typical of both land based and off-shore turbine generators. The view 1 from behind the turbine facing the wind includes tower 6 extending up from the ground or ocean surface 2 to support the nacelle 8 which contains the generator and gear reducers, unless it is a direct drive generator. There are typically three blades on a utility scale wind turbine having root ends 10 and blade tips 21. As seen from the side view 2, the blade root ends attach to the rotatable hub 18. Blade side 16 facing the wind 4 is often referred to as the high pressure side. The blade side 14, facing away from the wind is referred to as the low pressure or suction side. As the blade speed increases the blade pitch is adjusted to the optimal angle of attack to the wind to create the maximum lift and torque required to drive the electricity generator.

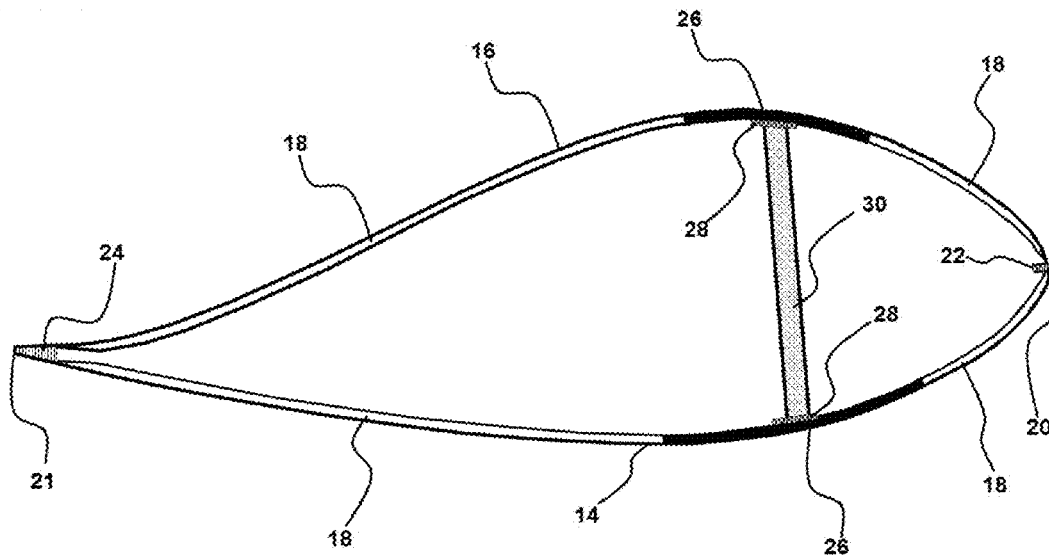
Fig. 2

FIG. 2 is a schematic representation of a wind turbine blade cross section.

FIG. 2 shows the construction cross section of a typical HAWT blade. Wind turbine blades are generally manufactured with adhesively bonded composite shells forming the high pressure side 16 and the low pressure side 14. The trailing edge 21 is adhesively bonded as is the leading edge 20, with adhesive bonding in some cases between two flanges 22 formed by the inner and outer fiberglass skins that make up sandwich panels 18. Two spar caps 26, which may be made from fiberglass or carbon fiber laminate are bonded to the edges of the sandwich panels 18. The blade spar web 30, which can be a solid fiberglass laminate or a sandwich construction with fiberglass or carbon fiber face sheets and a core material made with foam, balsa wood or other suitable material with high compressive strength. The spar web 30 is bonded with adhesive 28 to the spar caps 26 to form an I beam. Sometimes a second or even third spar web is present forming a box beam.

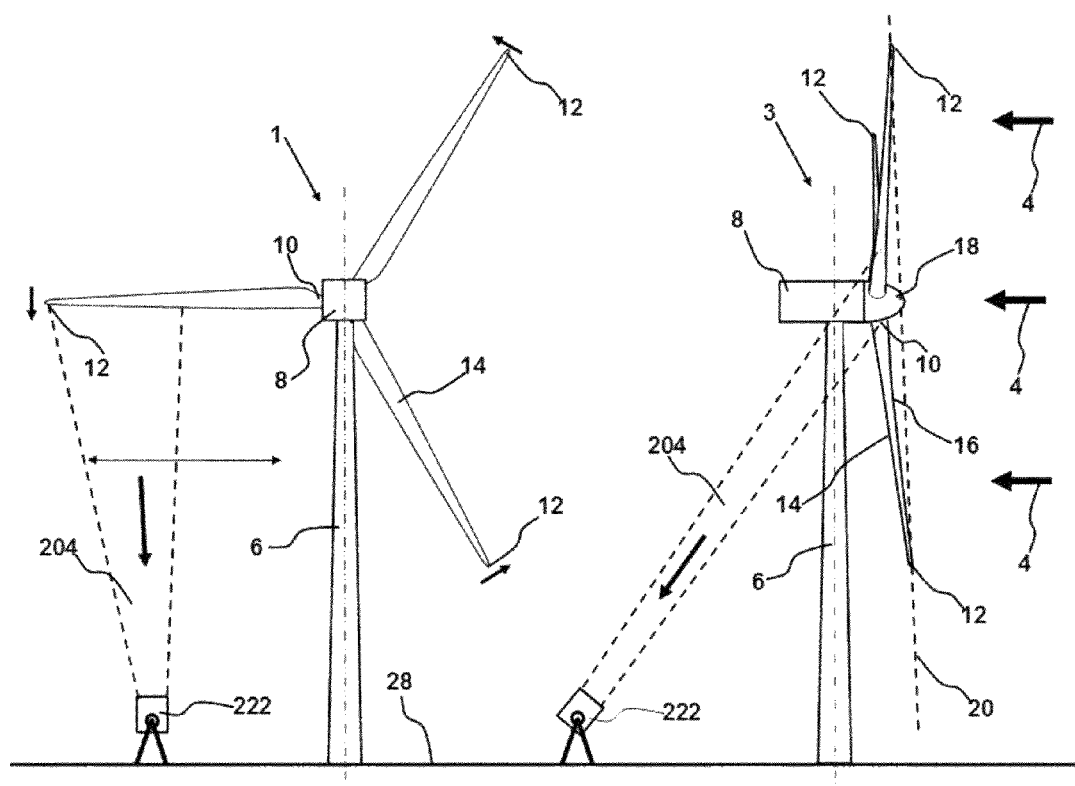
Fig. 3

FIG. 3 is a schematic diagram showing the relative location of a thermal camera for inspecting the wind turbine blades that are oriented so as to be substantially perpendicular with respect to the ground or sea level;

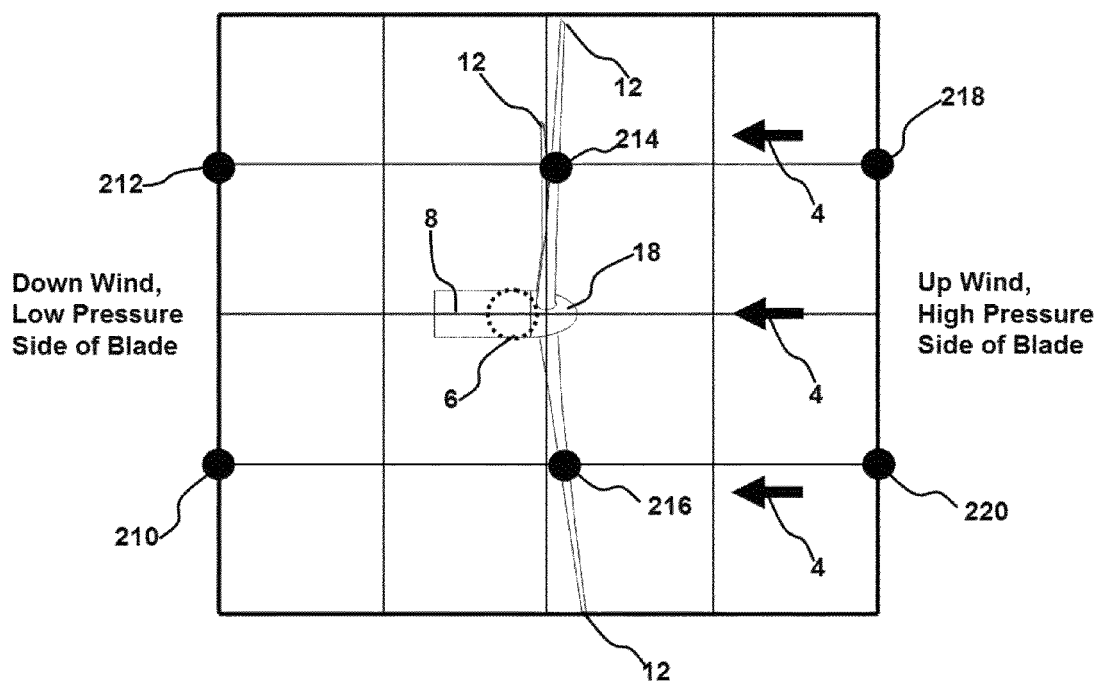
Fig. 4

FIG. 4 is a diagrammatical plan view of a wind turbine site with an indication of six placement locations for the thermal camera to view various locations on the blades;

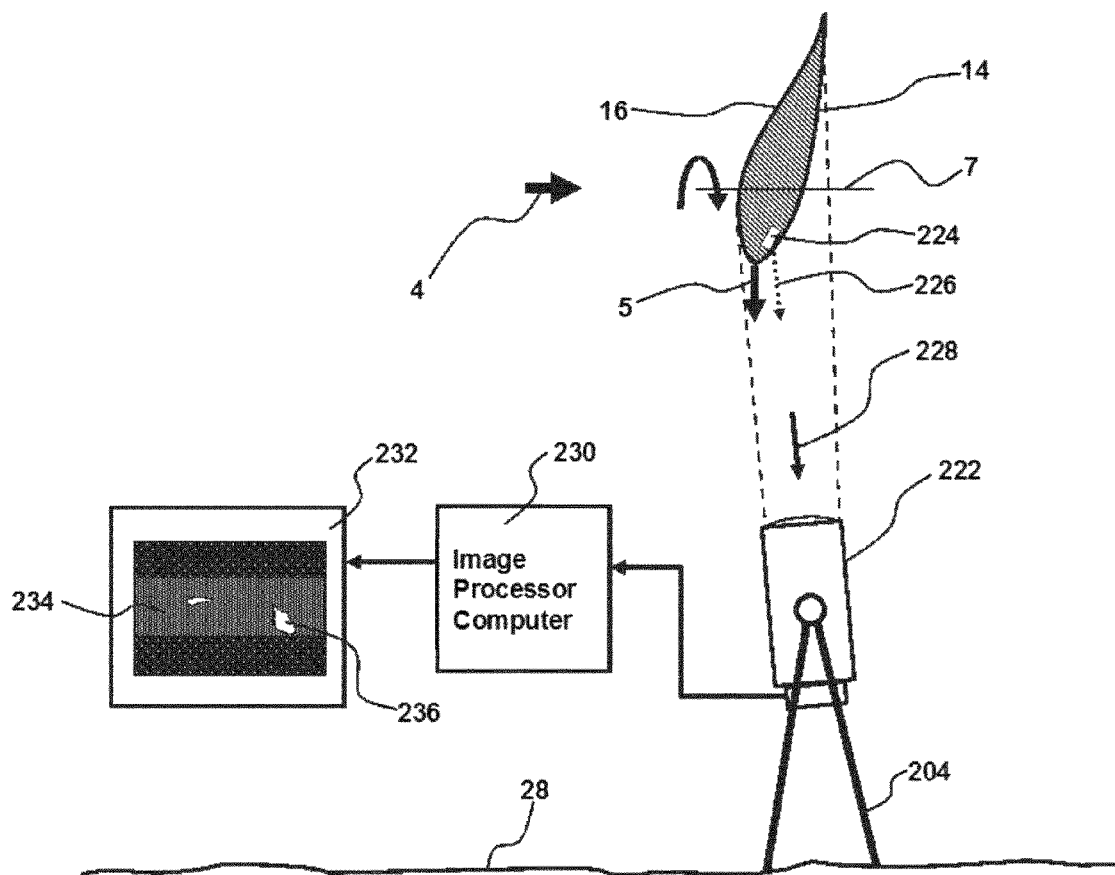
Fig. 5

FIG. 5 shows a basic thermal system including an image processing computer that is suitable for direct viewing and recording blade surfaces in or near a wind turbine site;

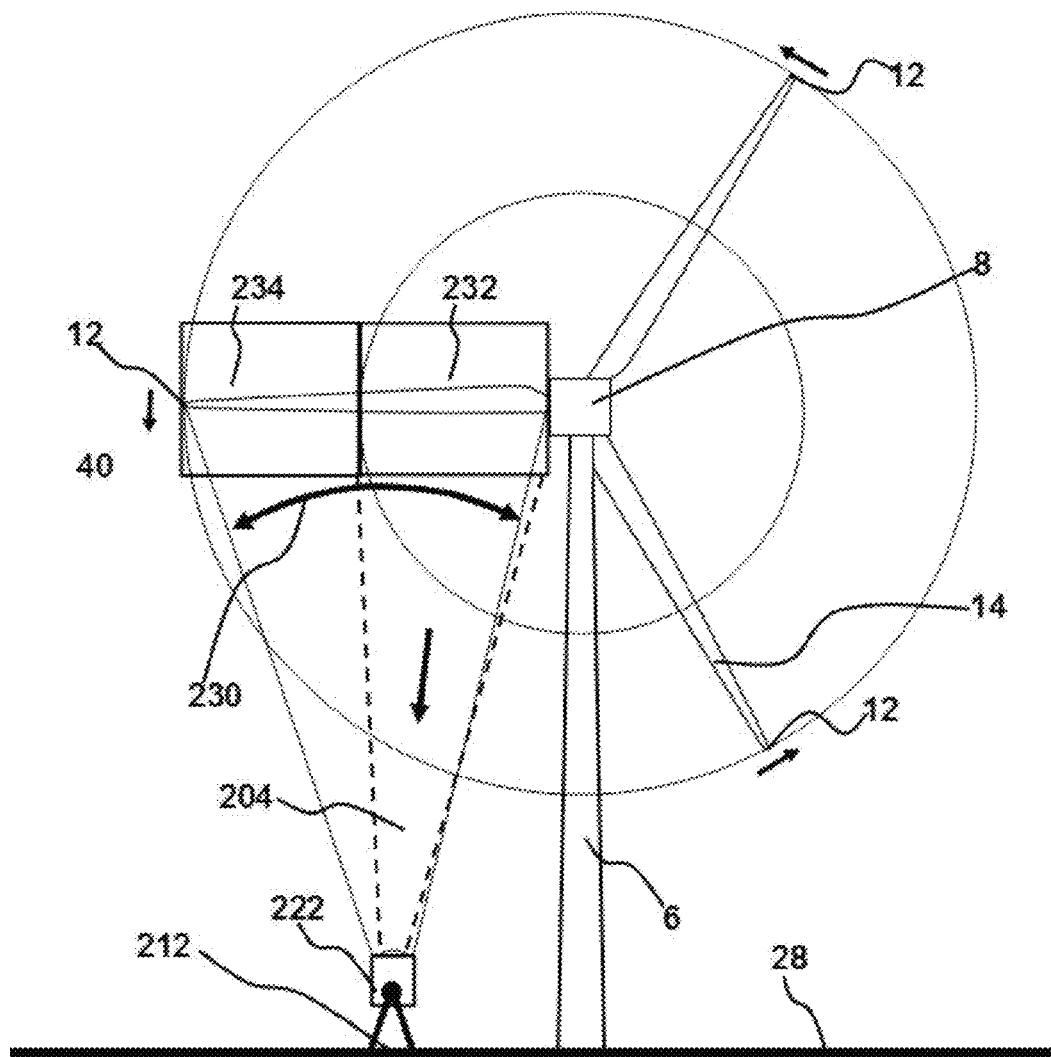
Fig. 6

FIG. 6 a schematic showing the thermal camera viewing a low pressure, or suction side of a blade in the horizontal position.

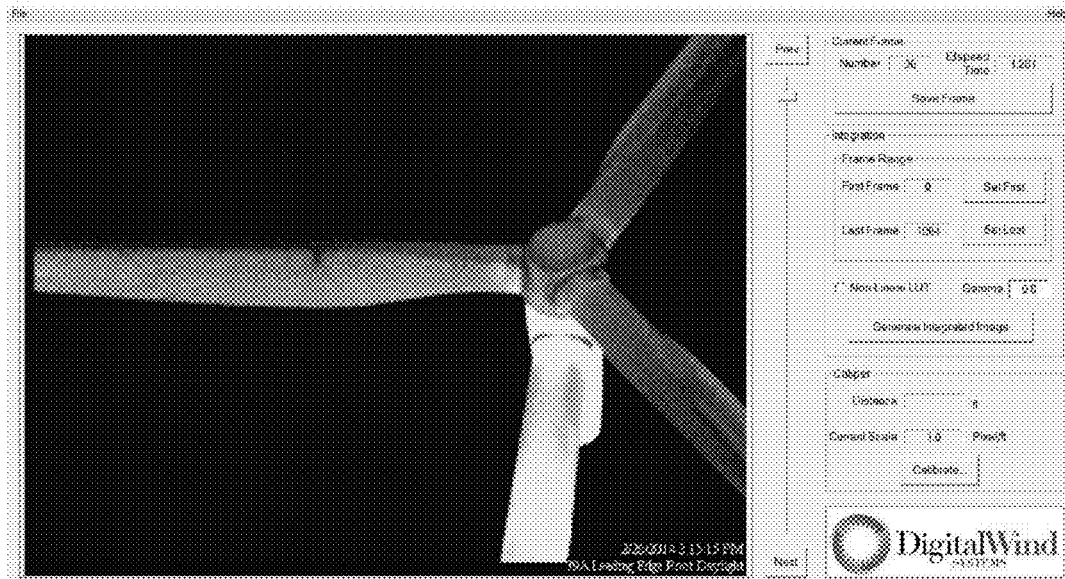
FIG 7

FIG. 7 is a screenshot of a display image generated by the image processing computer showing a thermal image of the high pressure side of an operating wind turbine rotator with a video frame selected with the blade positioned horizontally blade showing a dark defect during nighttime;

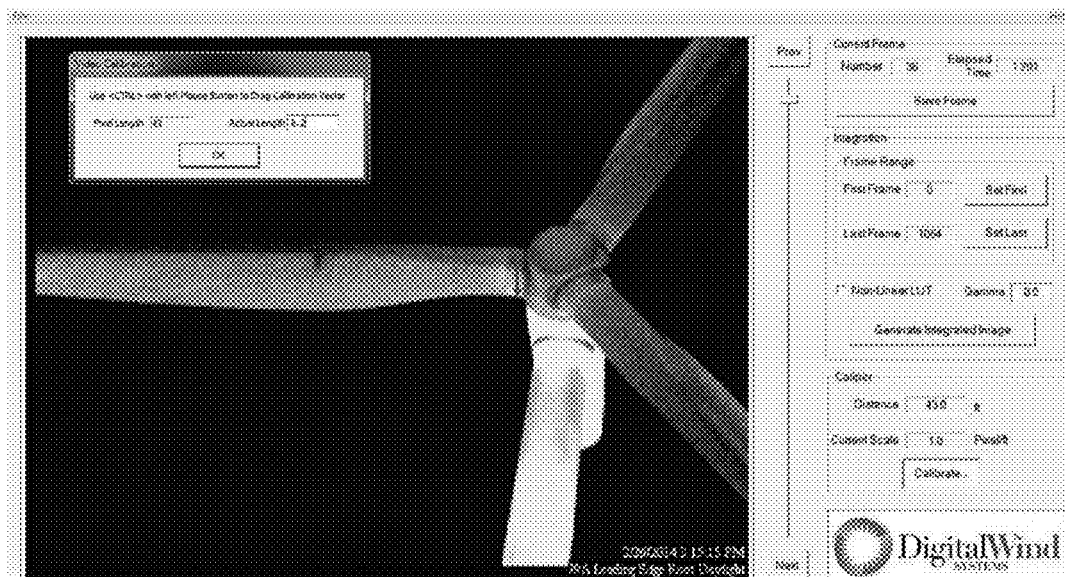
FIG 8

FIG. 8 is a screenshot of a display image generated by the image processing computer showing the use of a caliber overlay function to mark on the digital image the width or diameter of the cylindrical root end of a blade;

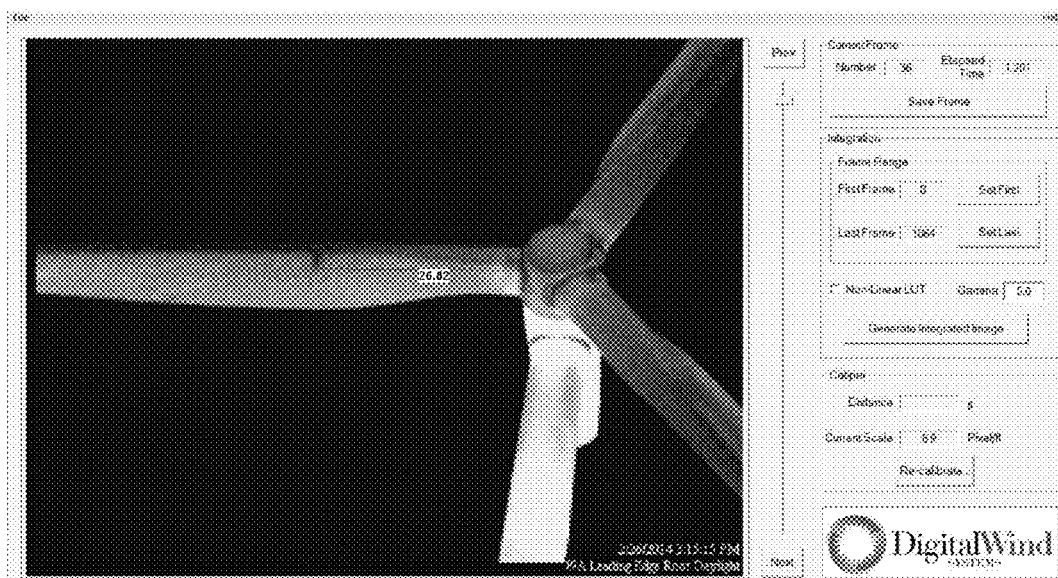
FIG 9

FIG. 9 is a screenshot of a display image generated by the image processing computer showing the use of the caliber overlay function to determine a distance between the blade root end and the black indication of a defect in a wind turbine blade;

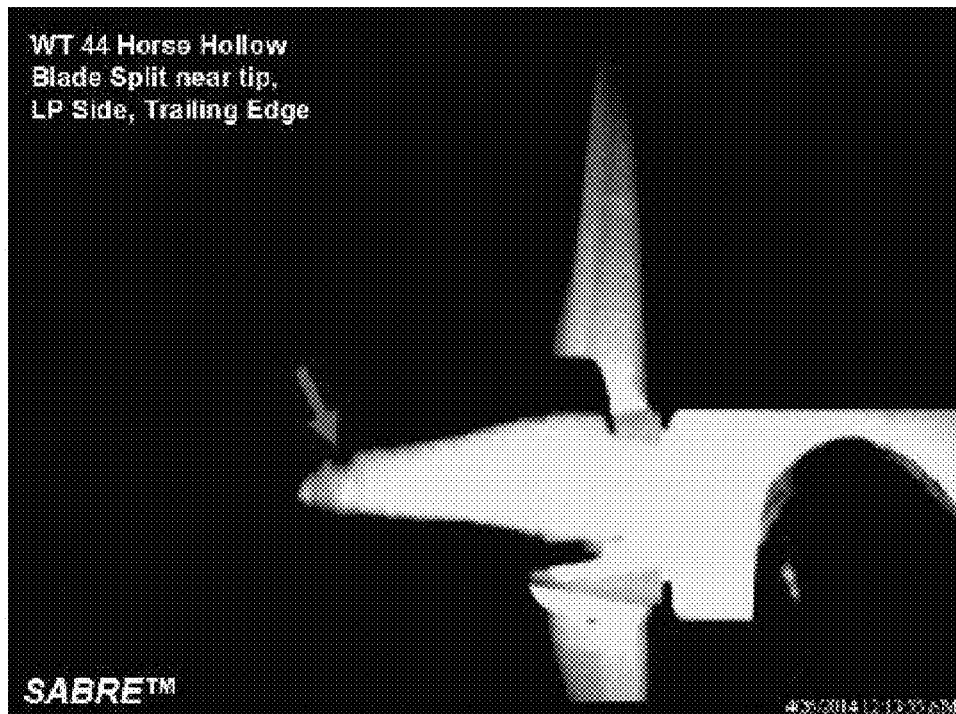
FIG 10

FIG. 10 is an infrared image showing a flaw in a wind turbine blade near the tip of the blade;

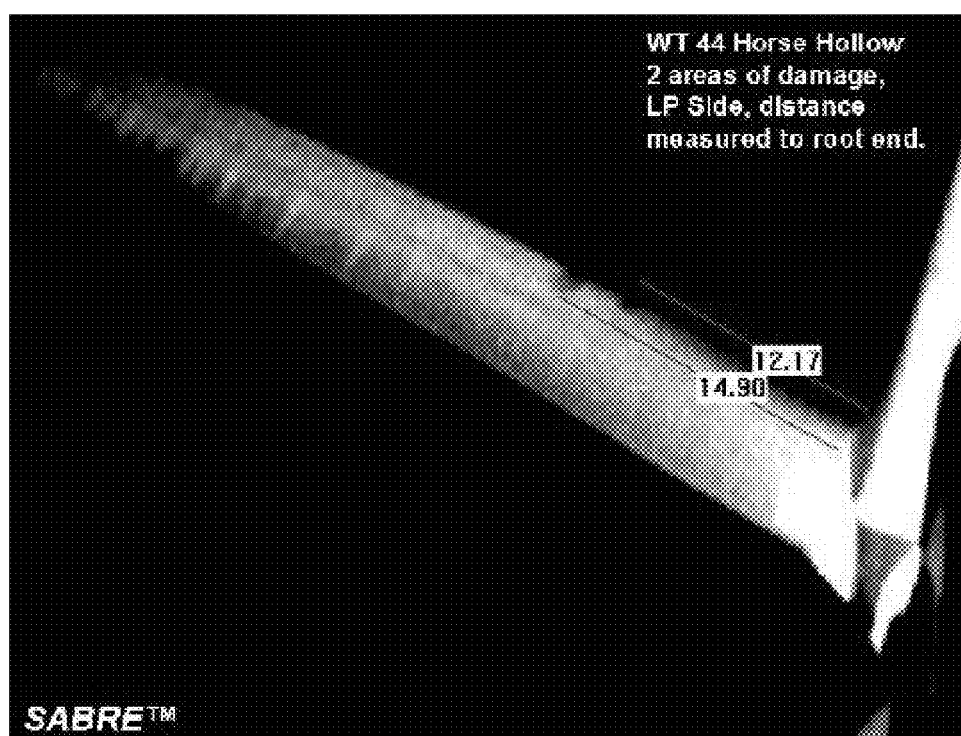
FIG 11

FIG. 11 is an infrared image showing the caliber overlay function being used to measure the location of two areas of damage on a wind turbine blade with respect to the blade root end; and

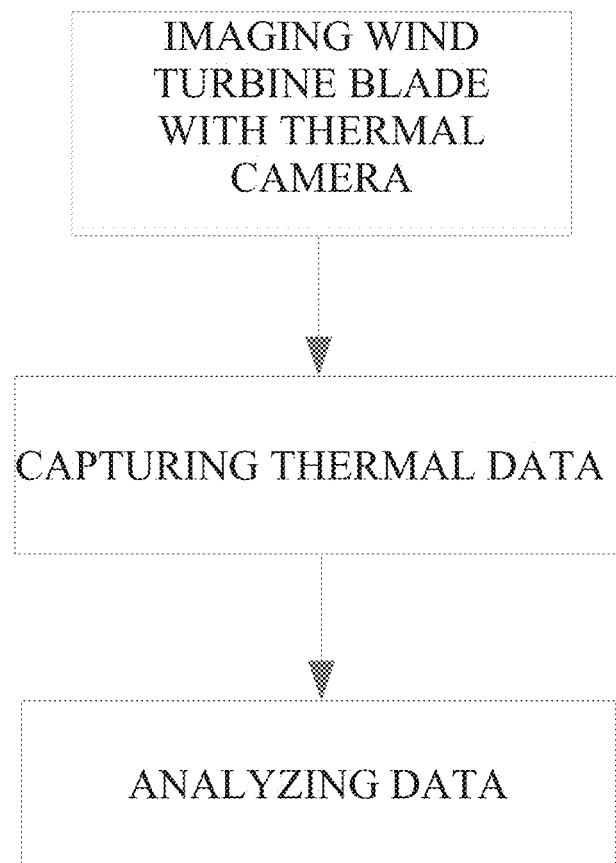
**FIG.12**

FIG. 12 is a flowchart depicting a method according to a preferred embodiment of the invention.
